## The 4900 Single Board Snack, OBA and CBA-2

# 4900 Single board ,OBA Bracket

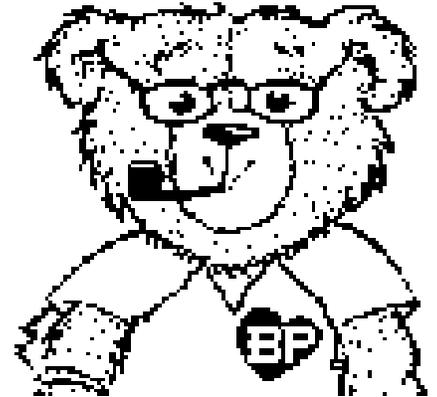
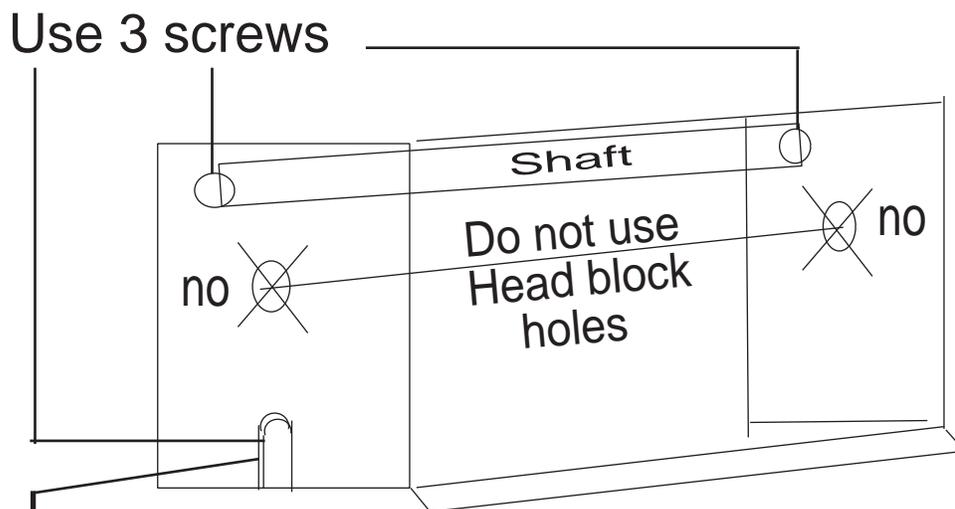
Part # 308785-01 with "slot"

With an OBA with a new Head assembly (no metal inserts for screws) use the Hold-Down wire springs [ part #35112301] and use the newer OBA 4900 bracket. Use only three (3) screws. If you have the older bracket which does not have the slot-hole, drill a new hole in the older bracket.

No slot, then drill a new hole in the bracket !
