**ROWE BILL CHANGERS BCxx00
BUCKET POWER ON ERRORS!**

March 04, 2005

Bruno D Puglia

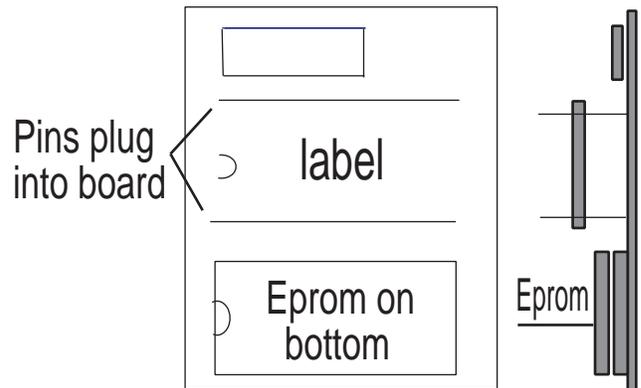
New version adapter board for converting 65069006 and 65069011 boards into new \$5,\$10,\$20 boards
