Rowe BCxx00 Bill Changers BC100,150,200,1200,1400,2800,3500

An overview by Bruno D Puglia
EAST COAST ADMUSEMENTS
Canton, MA

<http://www.eastcoastamusements.com/>
March 10, 2005

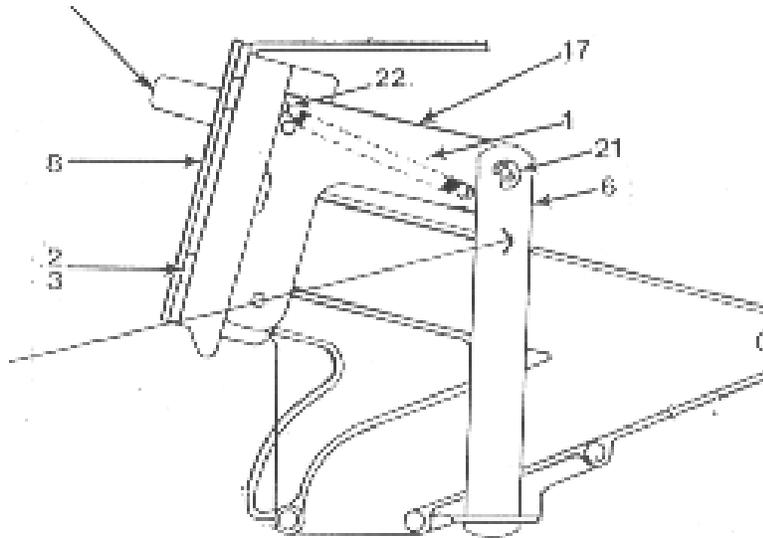
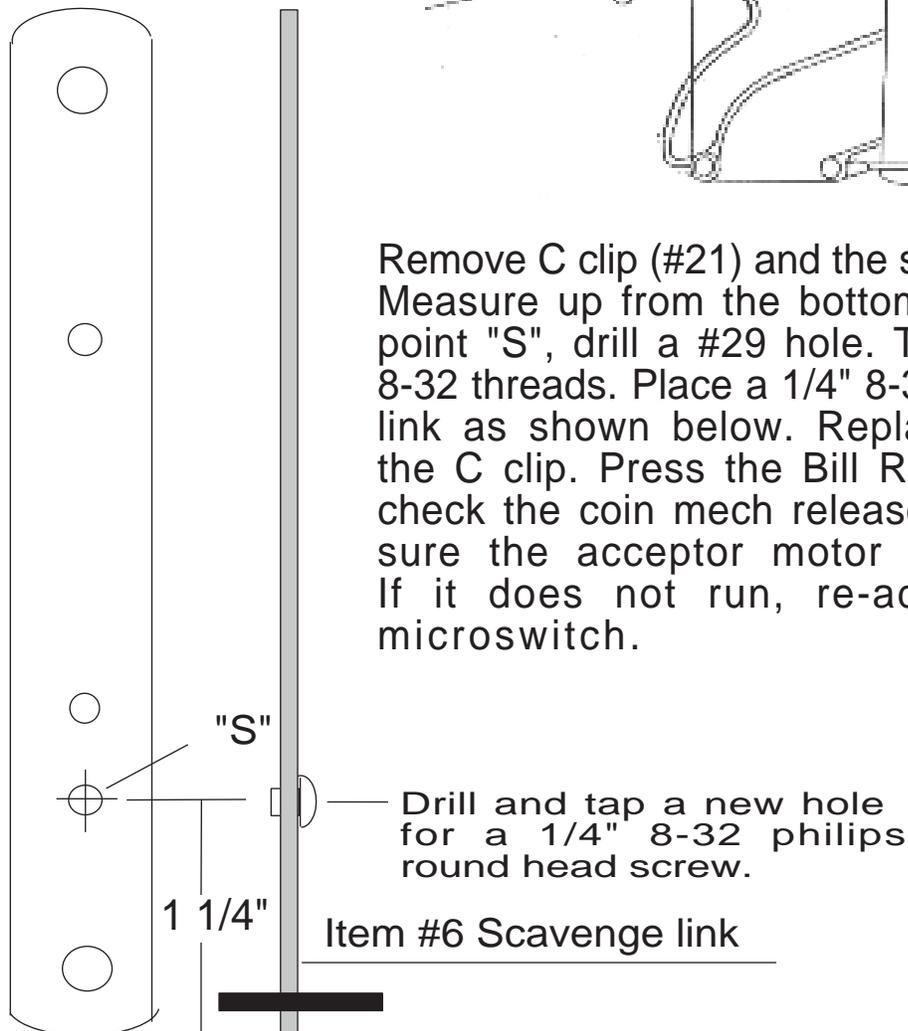
Item #6 Scavenge link

When Rowe started using the Imonex coin mechs in the BC-3500, many coin mechs were damaged. Imonex beefed up the pivot pin but they still broke. I worked out a fix which was to put drill and tap a new screw hole in the bill return scavenge link to limit the downward travel of the link into the coin mech. Rowe later did the same thing. I will attach the BCcoin1 Bear note page to this article to show up how to make the fix in case your BC3500 changer does not have the fix or you put a Imonex coin mech in an older BC3500 or a BC-35 changer. In case you do not use the coin mech I recommend blocking the coin slot with Rowe's Coin Block kit. # 270298-01.

Rowe now installs this screw in BC3500s.

We want to stop the link from going too far down into the coin mech. By adding a screw in the link we can restrict the downward travel into the coin mech. This will prevent damage to the coin mech.

Remove C clip (#21) and the scavenge link (#6). Measure up from the bottom 1 1/4" and this point "S", drill a #29 hole. Tap the hole with 8-32 threads. Place a 1/4" 8-32 screw into the link as shown below. Replace the link and the C clip. Press the Bill Return button and check the coin mech release and also make sure the acceptor motor runs in reverse. If it does not run, re-adjust the return microswitch.

Drill and tap a new hole for a 1/4" 8-32 philips round head screw.

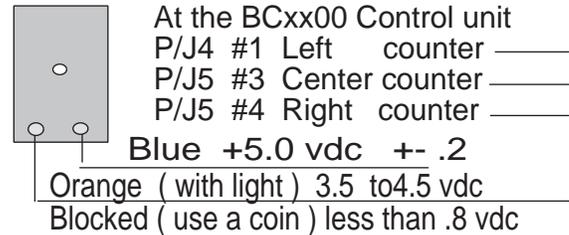
Another part of the coin count system system is the photo cell assembly. Use a meter to check the cell's operation. You need + 5 vdc on the blue wire. You should have => + 3.5 vdc on the orange wire with the LED shining on the cell. When the light is blocked the voltage should below .6 vdc. Refer to the manual for details You may have to push function reset button to clear a coin detector error after doing any testing.

I use the meter on the orange wire to find the peek in voltage has I align the LED assembly. This is better than eye balling the alignment.

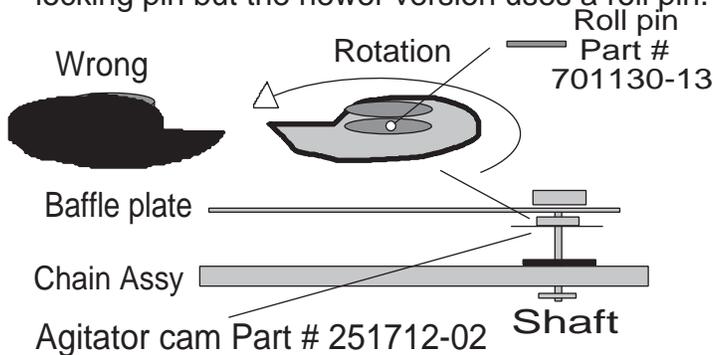
Hopper Upper Agitator Defect !

In March 1997 a vendor reported he had gotten upper agitator cams which were defective. The nylon cam was mounted on the metal ring backwards. We found half of the units in our parts box were backwards. We also found two hoppers in our machines with the backwards agitators. We replaced them. The defect may have first shown up in 1996 ! As the cam turns the small edge should start cutting into the coins.

On another note, early versions used an allen locking pin but the newer version uses a roll pin.
