## The 4900 Single Board Snack, OBA and CBA-2

# 4900 Single board ,OBA Bracket

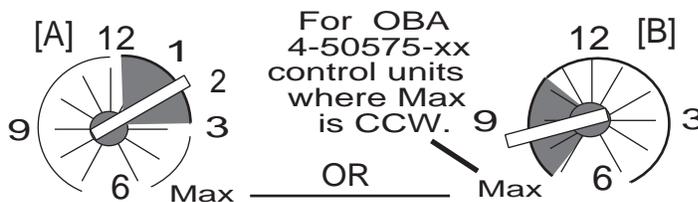
## Adjusting Rowe Mag Gains

There are many reasons to adjust the mag gain as listed below. If a speed adjust exists, adjust the speed FIRST. With an average bill, start at one end and insert the bill. Move one clock position and reinsert the bill and repeat the process until it is accepted. Note this position, say 12 noon. Go to the other end of the pot and repeat the process again going back one clock position till the bill is accepted. Say 3 pm. Set the mag gain between the 2 accept points (shaded area) at 1:30 or 2. See [A]. With OBA 4-50575-xx [B] units Max is CCW. You may find the range is between 7:30 and 10 so you would set the gain at 9 or 8:30. If it does not work when tested, repeat the process with another bill. In checking, you may find you get some rejections and the adjustment wants to be closer to the Max position or Min position. If the unit gives an error code when the bill is rejected. Use them and the manual as an aid. With the new \$5 conversion follow the procedure given in the installation note. Then you may have to try this system.
