Rowe BCxx00 Bill Changers BC100,150,200,1200,1400,2800,3500

An overview by Bruno D Puglia
EAST COAST ADMUSEMENTS
Canton, MA

<http://www.eastcoastamusements.com/>
March 10, 2005

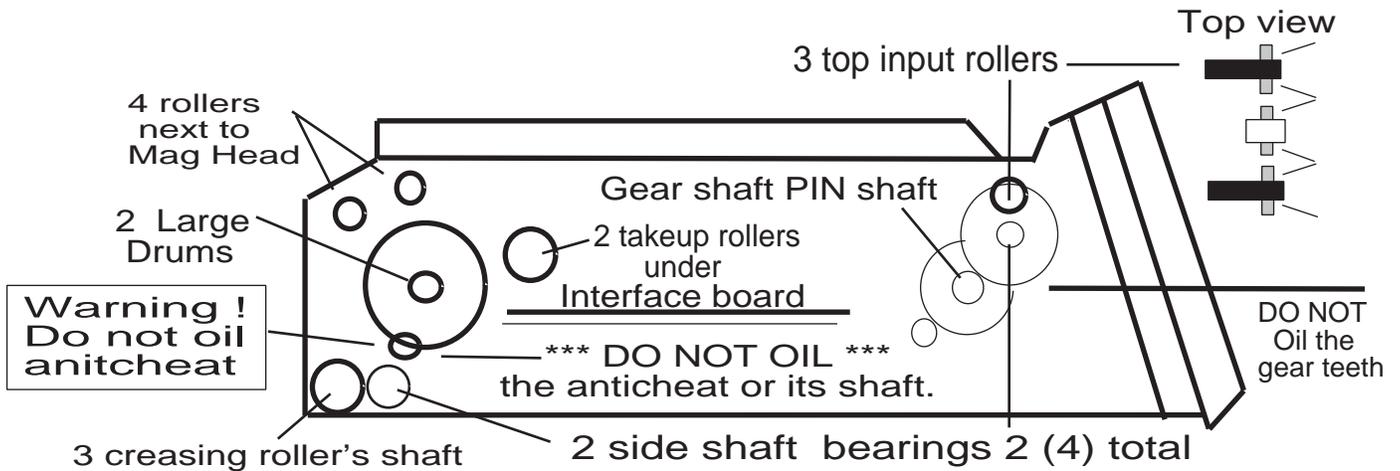
WARNING : DO NOT OVER lubricate or get oil on the belts.

Clean the photo cells and LEDs with Kodax lens cleaner, belts with rubber drive cleaner or denatured alcohol and the mag head pressure rollers with scotch tape or a magnetic pressure roller cleaning card. I have listed the information on Rowe's pressure cleaning card below. Even with normal use the ink from bills will contaminate the two pressure rollers. Keep those two pressure rollers clean.

Needle point lubricate every \$30,000 or at least twice a year.

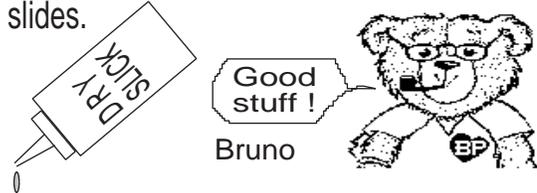
What can you use to clean Rowe hoppers and your coin mechs ? A product called Dry Slick is a very good cleaner when wet and when it dries, it leaves slick surface film which does not collect dirt. I do not recommend its use where a build up will cause a serious tightening. (such as tight shaft and nylon bearing). There is no problem when used on a Rowe hopper or on a coin mech area where the coin slides.

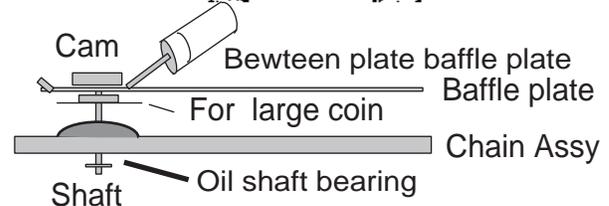
Never use WD-40 on a Rowe machine or acceptor

WARNING: Some of the hoppers I have seen lately have stripped holes. The metal used in the plate assembly, baffle plate, and even worst, the material used for the chain adjustment block can not take abuse. Automatic nutdrivers or drills can, and have, caused stripping of the holes. Extreme care must be used when tightening screws. The three chain adjustment screws need snug tension and the lock washers will hold the block in place. Fast is not better. Gross is not better !
